Manhole Inspection Summary

Manhole # S21K__051MH

Insp Date: **9/26/07 11:53 AM**

Location Address: **1735 PRATT ST**

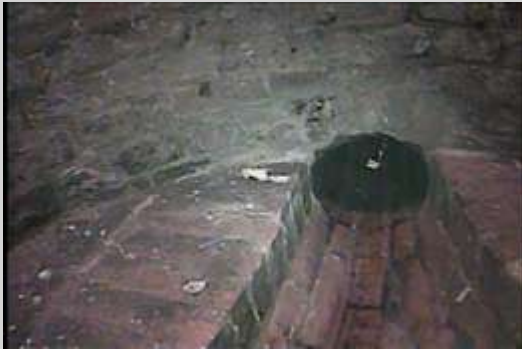
12 O'Clock Outflow

8 in. Circular Gravity Sewer
Pipe Out @ 12 O'Clock

Pipe Height: **7.2** (in.) Rod and Bar (Angled)
Pipe Material: **Clay** ☐ Pipe Lined
Invert Depth: **9.90** (ft.) Flow Characteristics: **Slow**
Deposits: ☒ None ☐ Mud ☐ Sludge ☐ Debris ☐ Grease
Silt Depth: (in.) Deposits Extent:
Infiltration: **None** Pipe Seal Cond: **Sound**

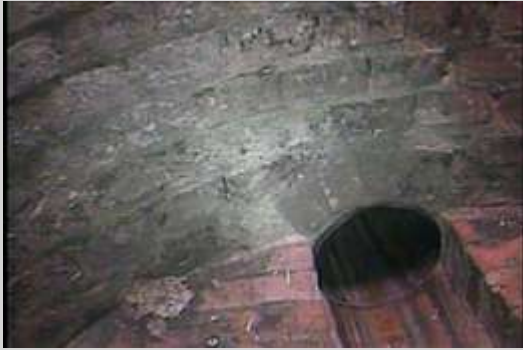
7 O'Clock Inflow

8 in. Circular Gravity Sewer
Pipe In @ 7 O'Clock

Pipe Height: **7.2** (in.) Rod and Bar (Angled)

Pipe Material: **Clay** ☐ Pipe Lined

Infiltration: **None** Pipe Seal Cond: **Sound**
